Row Crop Drip Irrigation on Peppers Study

High Rise Farms

REPORT

California Energy Commission

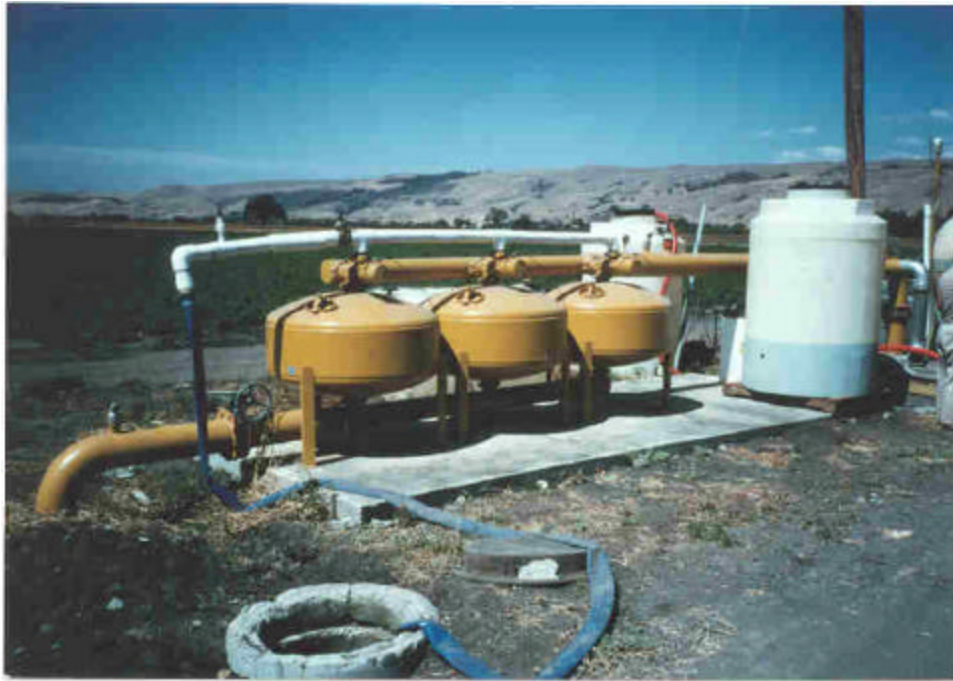
Figure 3-1. Sand media filter installation.

Three 48" diameter filter tanks were installed for the filtration. The tanks were manufactured by Atek. The backflush valves supplied were manual. These tanks are black painted steel.

- The sand media filters are being changed to simple screen filters. The grower has found that a Yardney screen filter provides his system with adequate filtering protection. He starts the drip irrigation system with the screen filter thru-flush lines open until the sand clears from the water. This clears out any sand from the wells. The filter change is cost driven - media tanks are \$10,000 versus \$1,200 for screens.

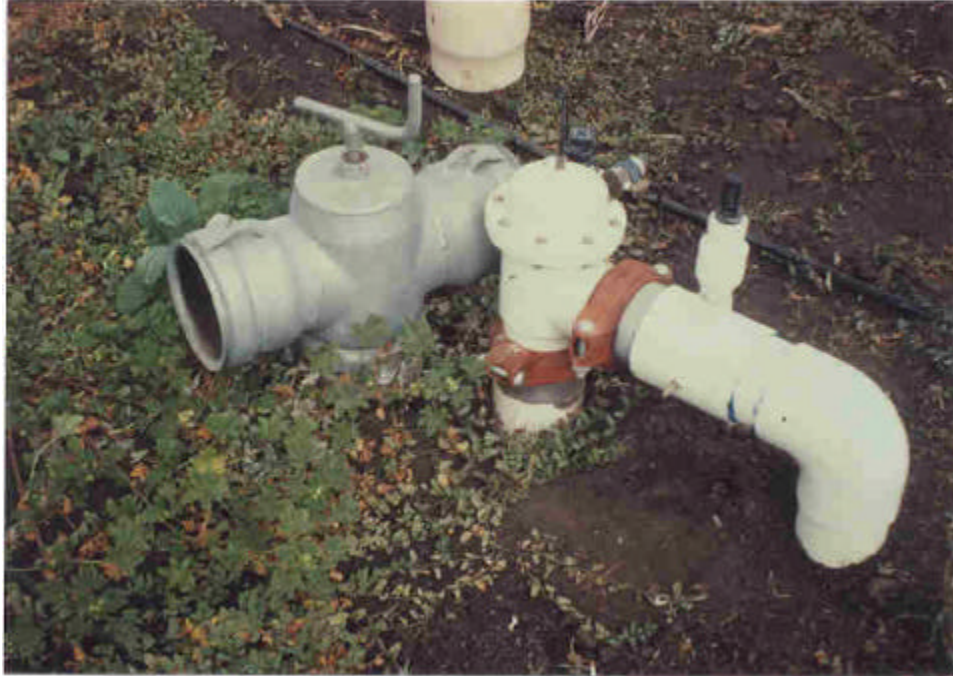
- The pressure regulators were a poor design. They were unable to maintain the desired pressure. This confirmed observations on other farms in the area.
- It is probable (but not confirmed) that the oval hose was compressed in the soil, thereby increasing friction. This would be consistent with other designs in the area. It should be noted that the findings regarding oval hose and the particular pressure

Figure 3-3. High Rise - Pressure regulator next to a sprinkler valve and riser. This model of pressure regulator was incapable of maintaining the desired pressure.

- Pressures vary tremendously throughout the irrigation system due to the fact that the new well pump supplies water at a lower pressure than the other two wells. The drip irrigation system's pressure changes every time a set is changed on any of the fields. This requires a manual field adjustment of all pressure regulators in the affected

blocks. To combat this problem, the grower plans to switch to a valve with a better design.
